**Policy and Finance Committee Meeting 15<sup>th</sup> April 2024**  
**Building Condition and Life Cycle / Planned and Preventative Maintenance**  
**Report**  
**Report of the Deputy Town Clerk**

# Weston-super-Mare Town Council

### Building condition and Life Cycle / PPM report 504524

28 March 2024

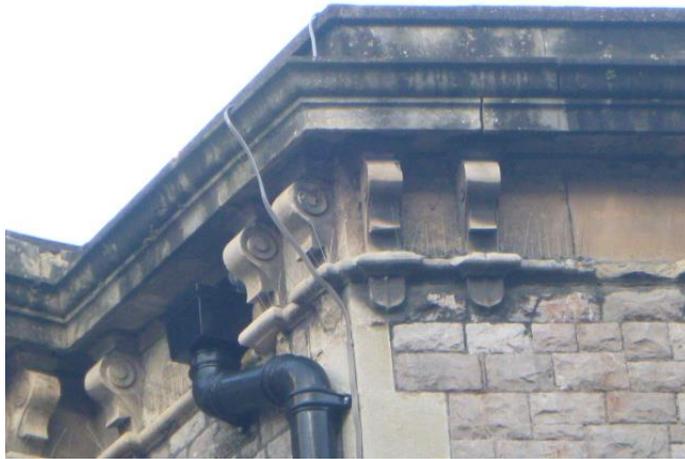
Photo 2.3: Front elevation corning with spalled stone eroded and pollution staining. Plastic hopper head and downpipe arrangement has previously been leaking causing stone saturation.

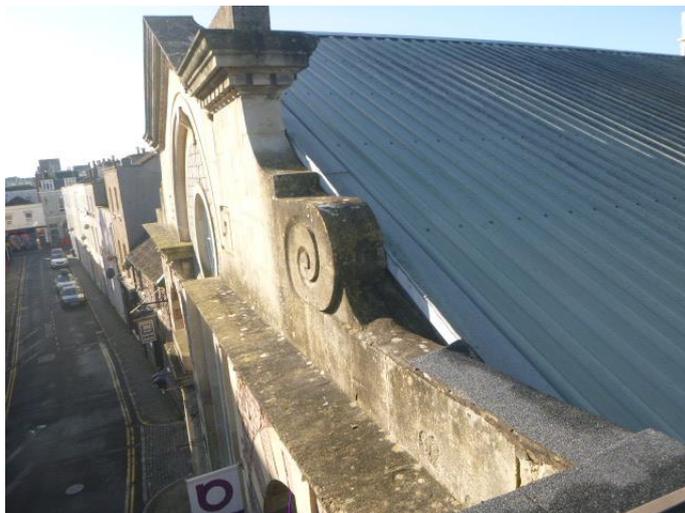
Photo 2.4: View of the front gable pediment and table stone course with general erosion and pollution staining.

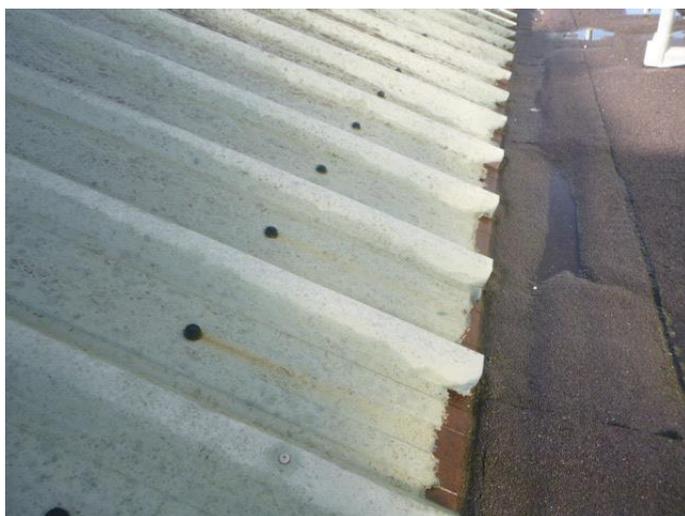
Cut edge corrosion is developing to the metal pitched roof over the auditorium and action is required in the short to term to treat and arrest corrosion and prevent more expensive repairs, if left.

Photo 2.7: View of cut edge corrosion to the metal colour coated roof over the auditorium.

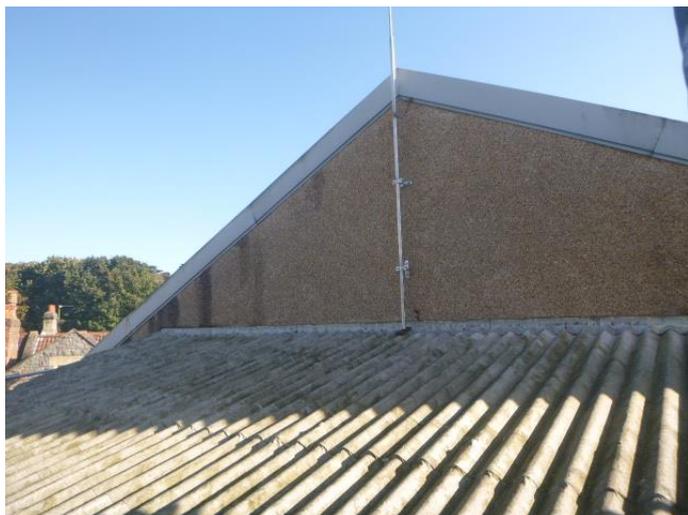
Photo 2.8: View of the rear lean-to roof with asbestos containing material.

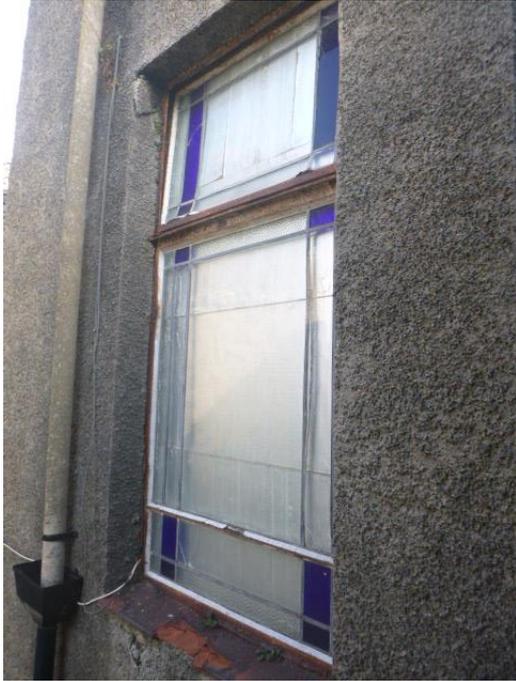
The metal frame windows are in a tired state of repair requiring action and maintenance over the next year(s) but over the next 20+ years total replacement will need to be undertaken and budgeted for.

Photo 2.11: Typical metal frame window unit with deterioration evident and unmaintained condition

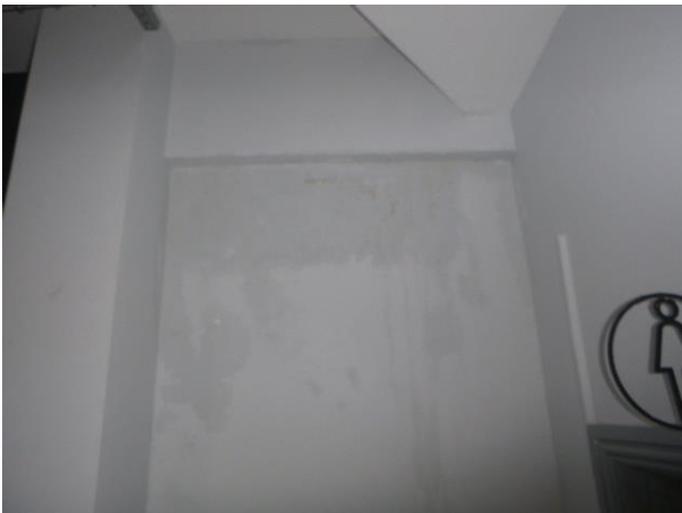
Photo 2.12: Dampness penetrating to the left elevation and migrating through to the entrance foyer

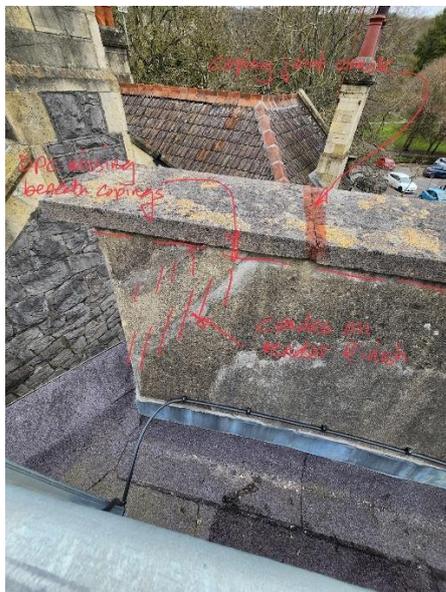
A subsequent inspection was made in March 2024 which identified a 4-metre section of the parapet wall that lacked a DPC beneath the coping stones. One of the coping stones was cracked and the joints were weathered. There was poor detailing at the parapet outlet that requires improvement. The outlet would typically be dressed to discharge into a hopper, but this arrangement is missing.

Photo 2.14: Cracks between copings and to render. DPC missing.

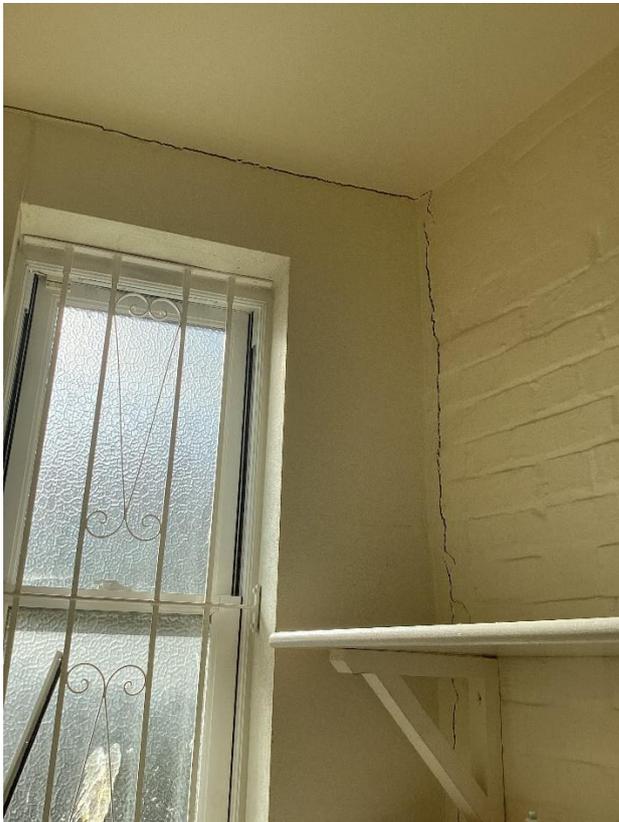
Photo 4.2.2  
Rear elevation.

Photo 4.2.3  
Cracking at high level in the  
Town Council Store. Further  
investigation advised. Possible  
lack of bonding between stone  
external wall and brick internal  
wall.

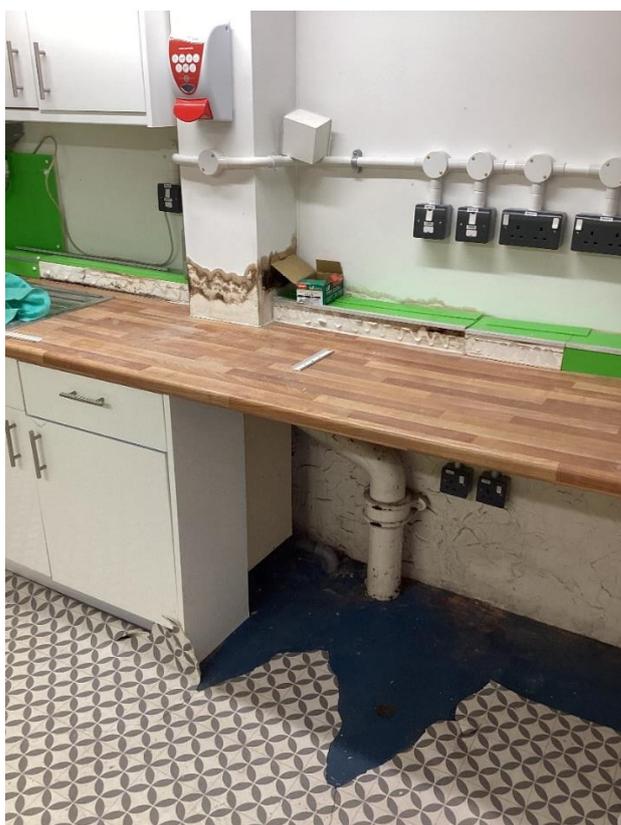
Photo 4.2.5

Damp stains to boxing in 1<sup>st</sup> floor kitchen and ripped vinyl flooring.

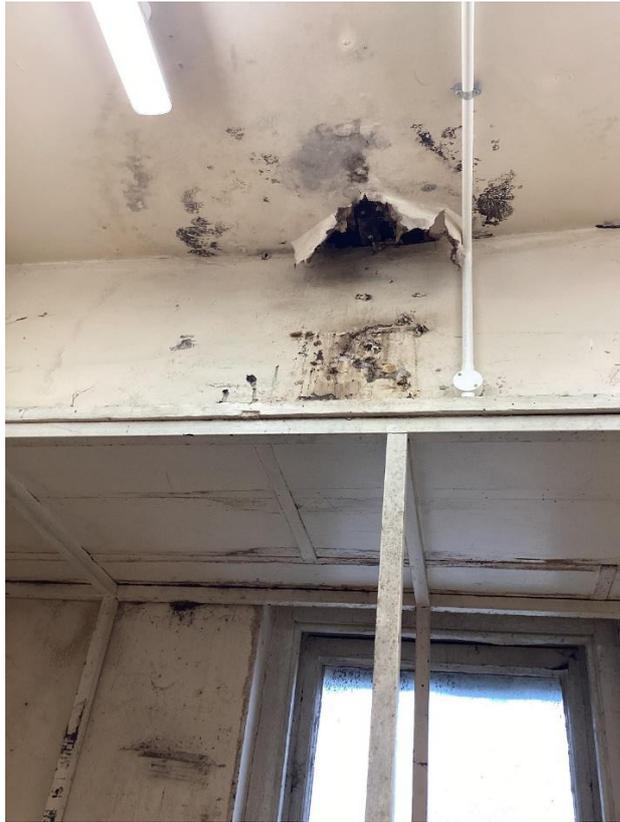
Photo 4.2.6

Damp penetration in the Town Council Archive room. The roof above here has recently been refurbished which is expected to have fixed the problem. Internal decoration still required.

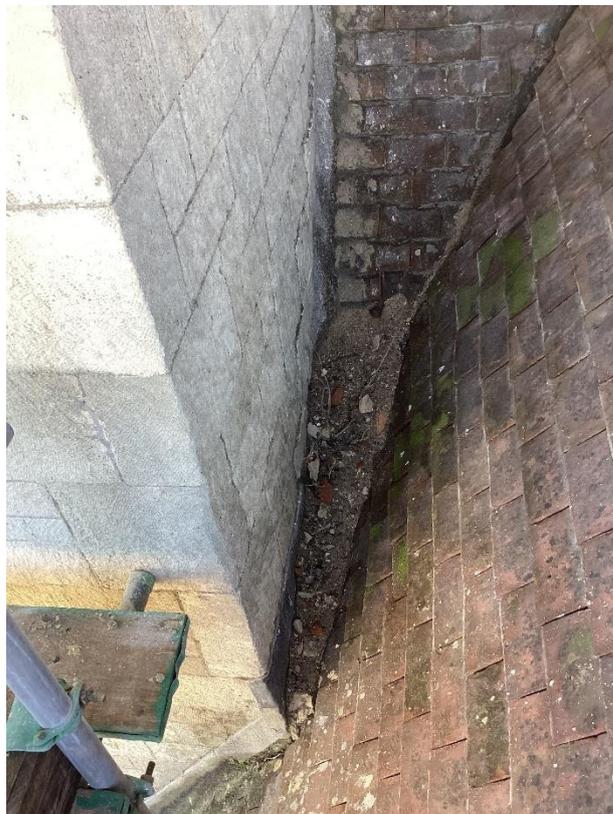
Photo 4.2.7

Built up of debris against wall to tower. Below here there is damp penetration to the Local Studies Room.

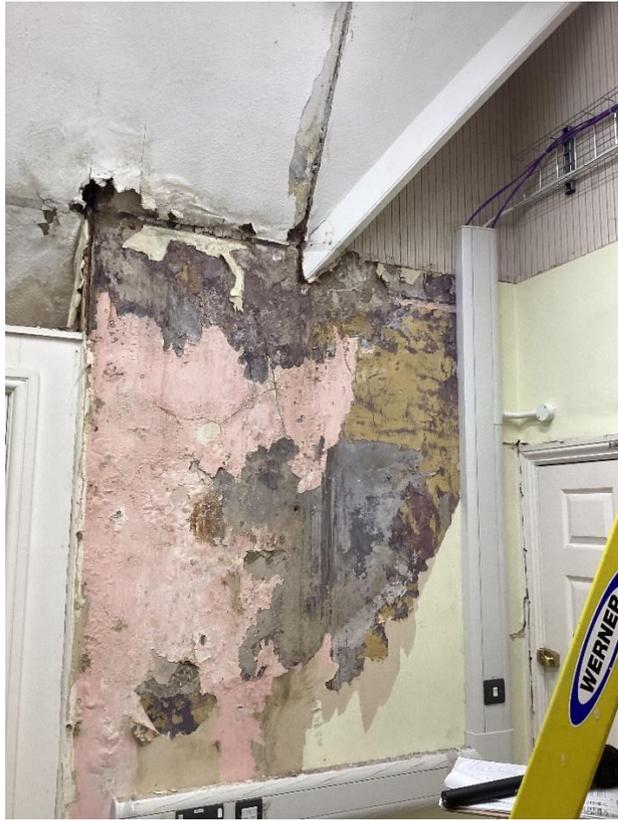
Photo 4.2.8

Damp penetration at high level in the Local Studies room. There is a pitched roof above here where it abuts the tower. Part of the roof to the rear has received a new breathable felt but I am unsure if all the roof has been refurbished. This part was not available for inspection externally due to the position of the scaffold.

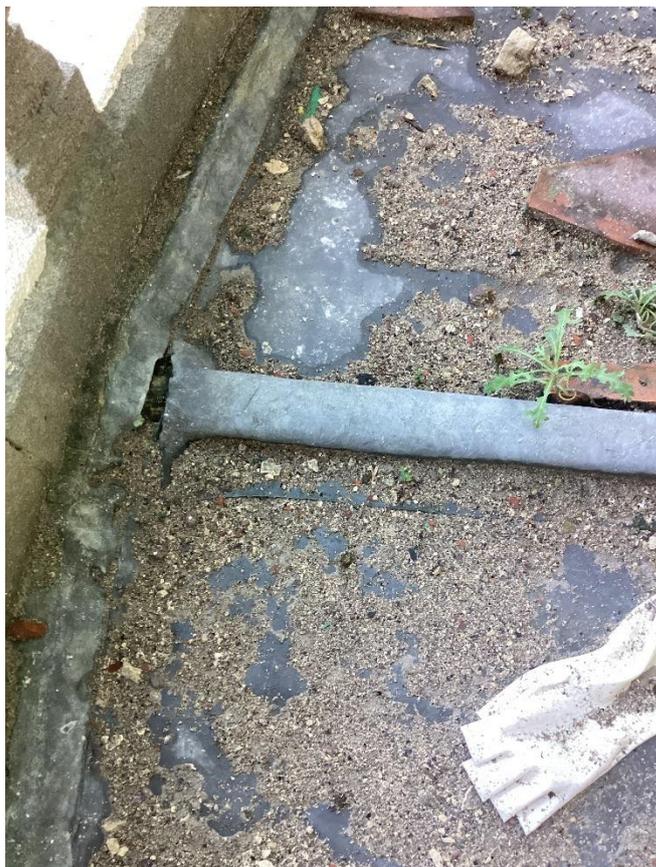
Photo 4.2.10

Split to roll joint at flat roof above  
Mayor's office.

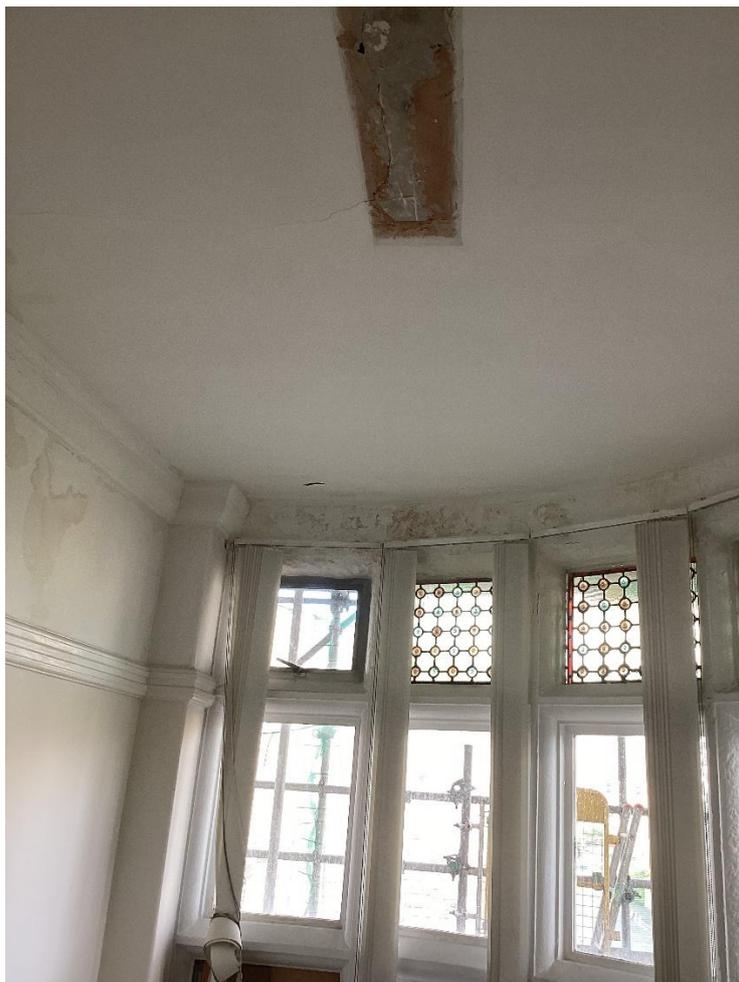
Photo 4.2.11

Damp penetration at high level to Mayors Office.

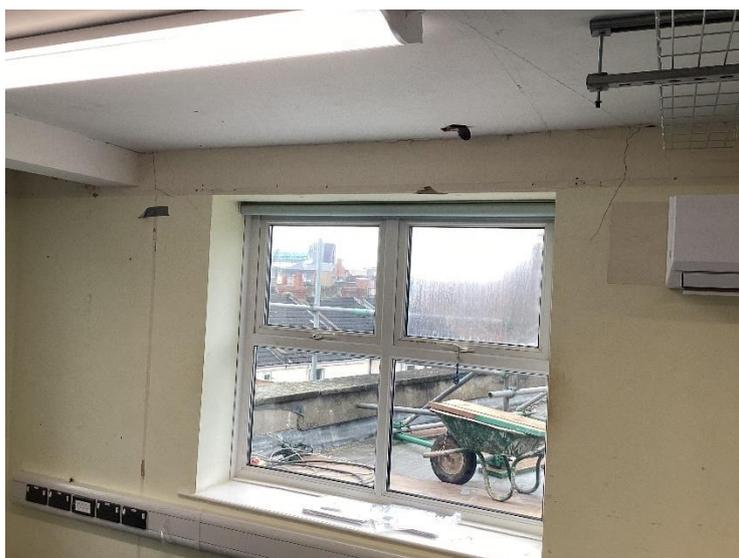
Photo 4.2.12

Cracking above window lintels at the 2<sup>nd</sup> floor. Further investigation advised.

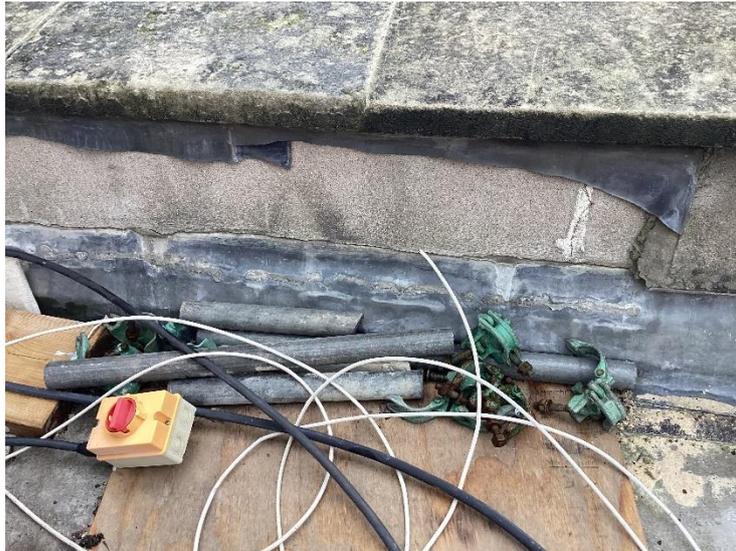
Photo 4.2.13

Missing lead flashings at parapet at the 2<sup>nd</sup> floor roof.

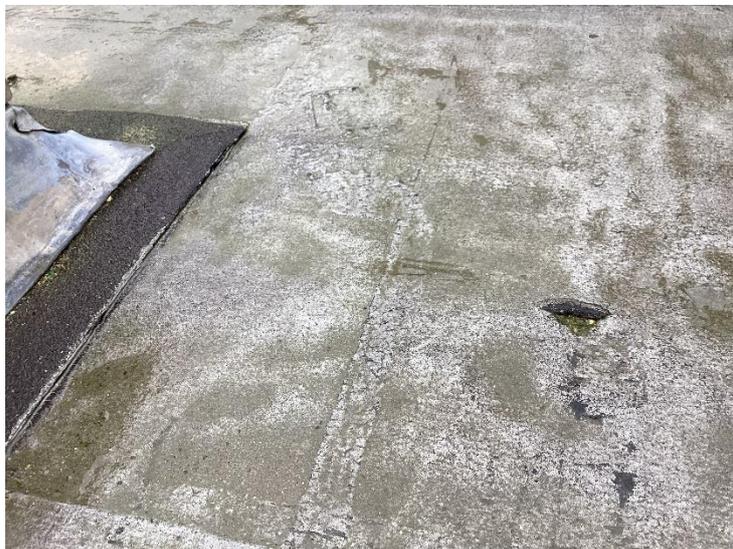
Photo 4.2.11

Localised damage to roof covering at the 2<sup>nd</sup> floor.

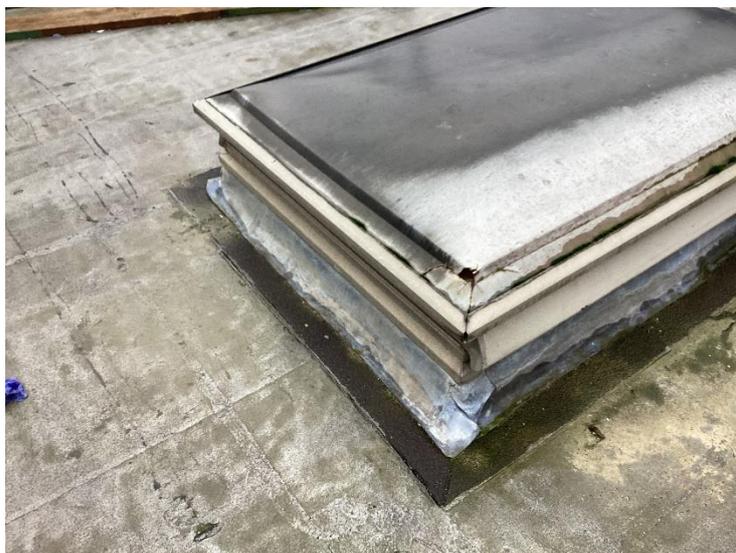
Photo 4.2.12

Deteriorating roof lights. Notes cracking to the edge of the polycarbonate cover.

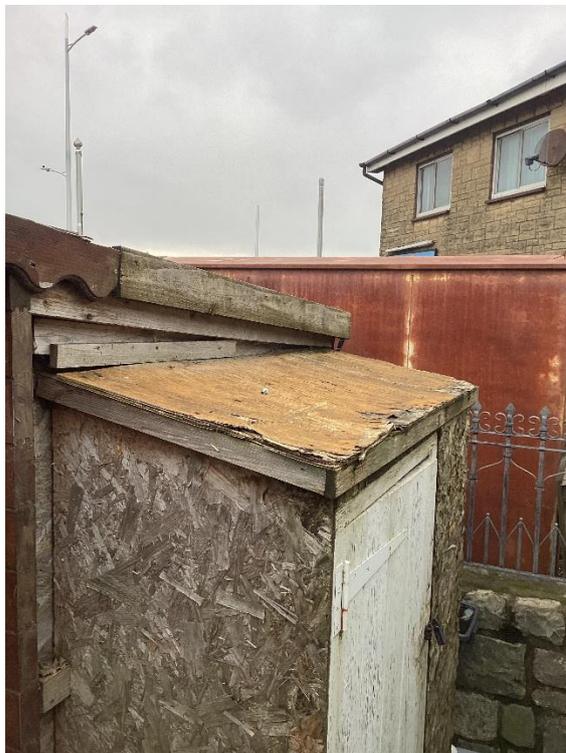
Photo 5.2.2

Water Park Café rear view with  
absent roof covering to lean-to  
extension.

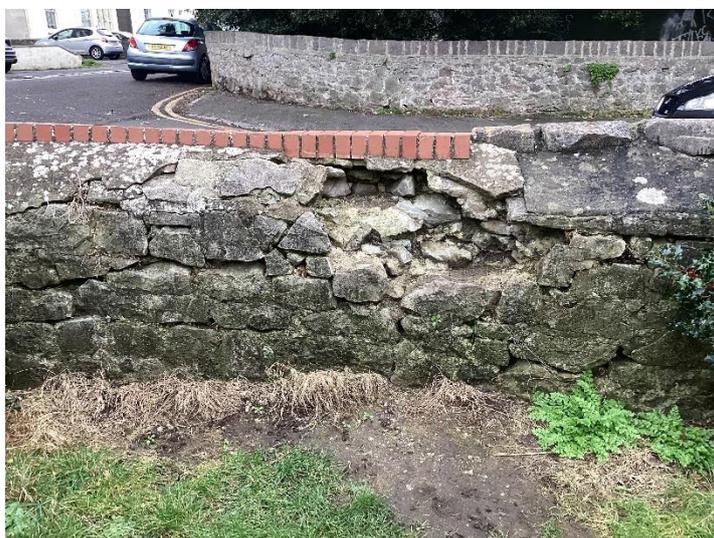
Photo 5.2.4

Poor condition of perimeter wall near Park Place.

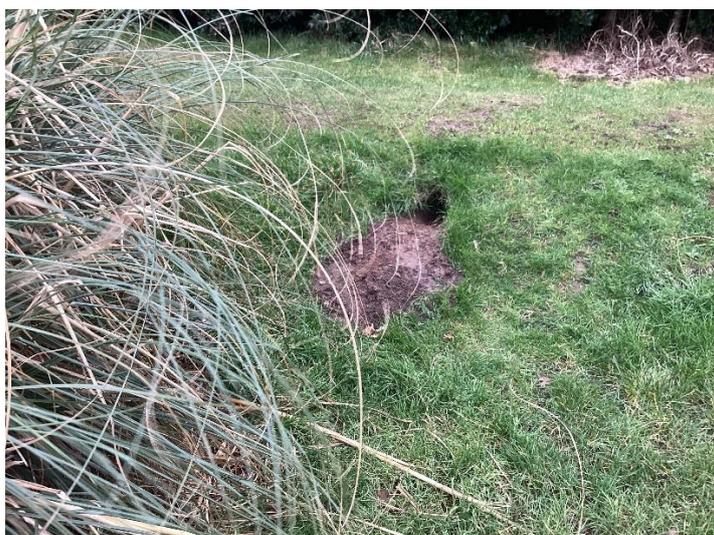
Photo 5.2.5

One of several animal sets across the site. These represent a trip hazard and further investigation is advised.

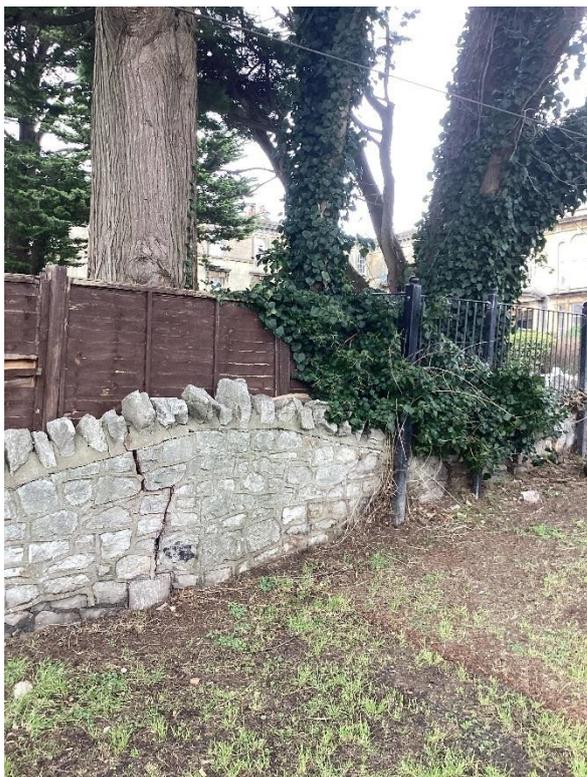
Photo 5.2.6

Large trees outside the site potentially undermining the stability of the wall. Further investigation advised.

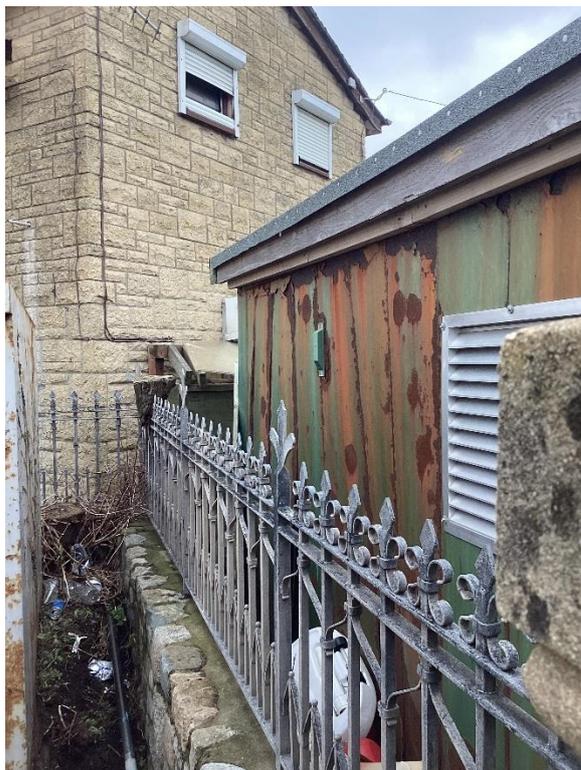
Photo 5.2.7

Severe corrosion to metal shed. The shed is approaching the end of its service life.

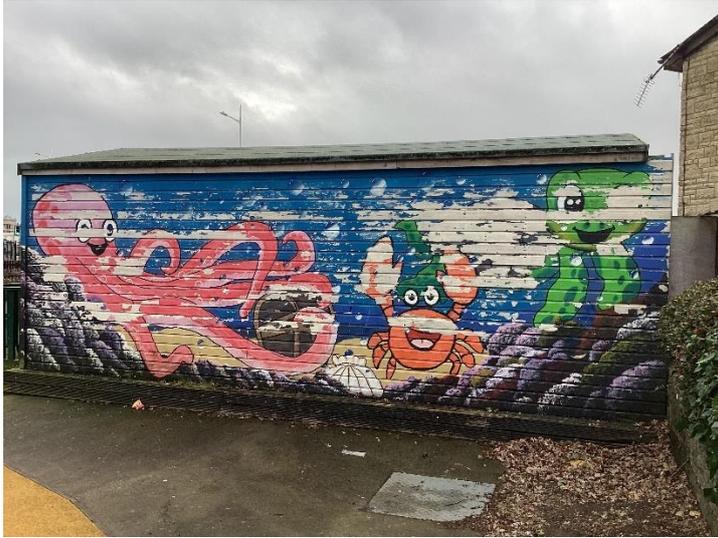
Photo 5.2.8

Colourful mural. Peeling paint in places.

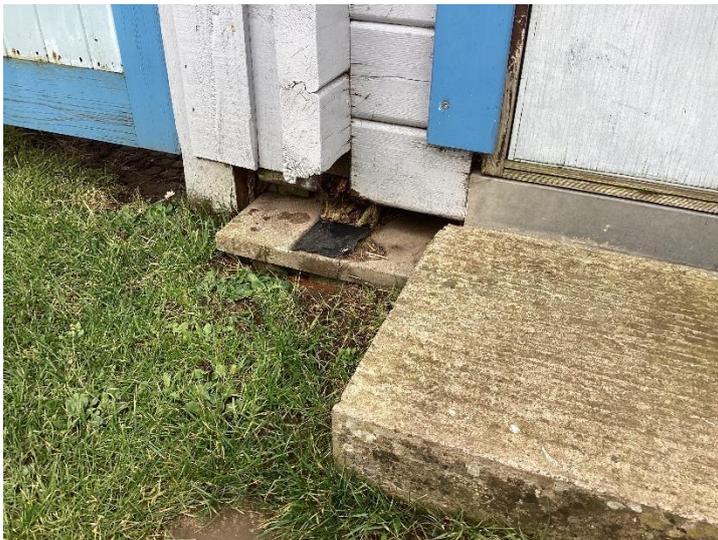
Photo 5.2.10

Rot to timbers at low level. Lack of upstand to these timbers leaves them at risk of further deterioration.

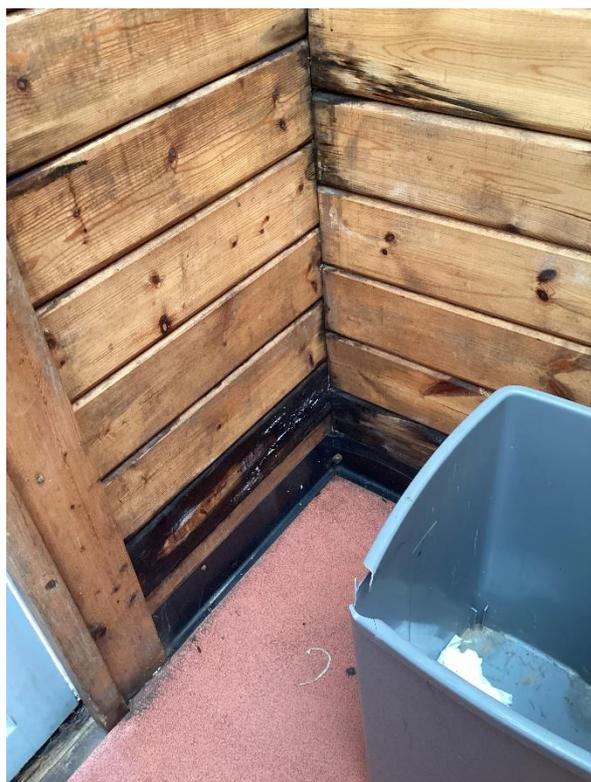
Photo 5.2.11

Further evidence of timber decay internally.

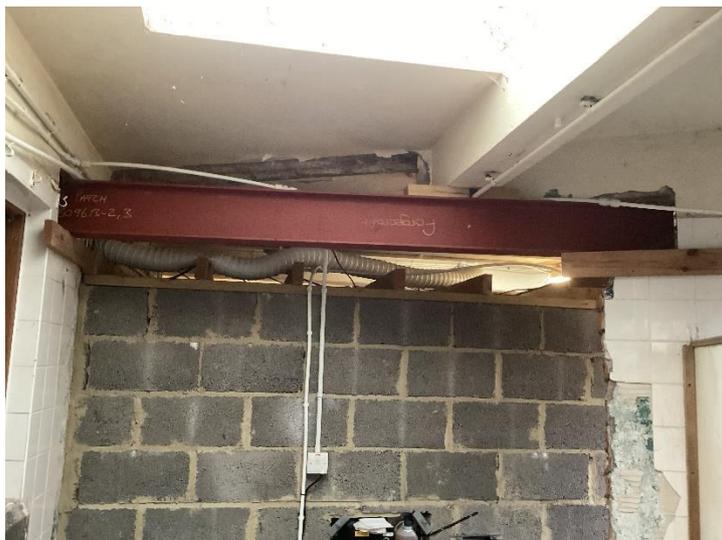
Photo 5.2.13

Structural beam. Shuttering for pad stones still in-situ. Allow for boxing in beam or consider fire protection measures.

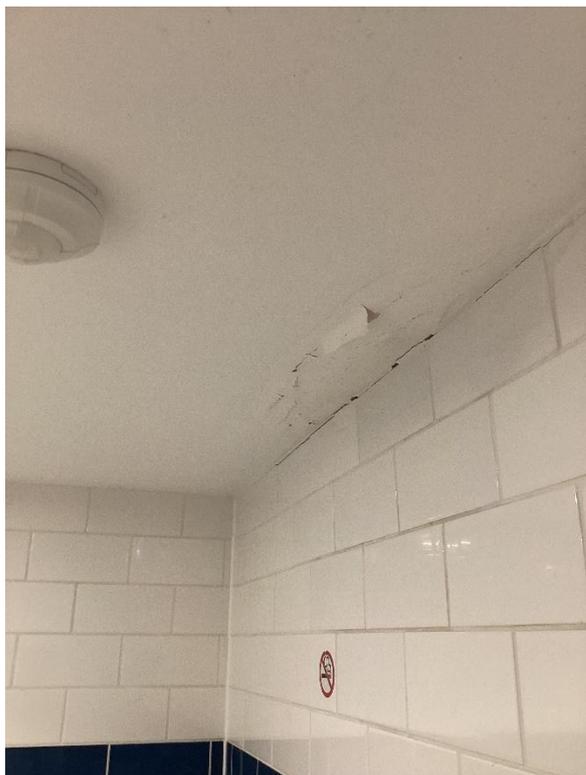
Photo 5.2.15

Flaking paintwork suggestive of damp penetration. Further investigation advised.

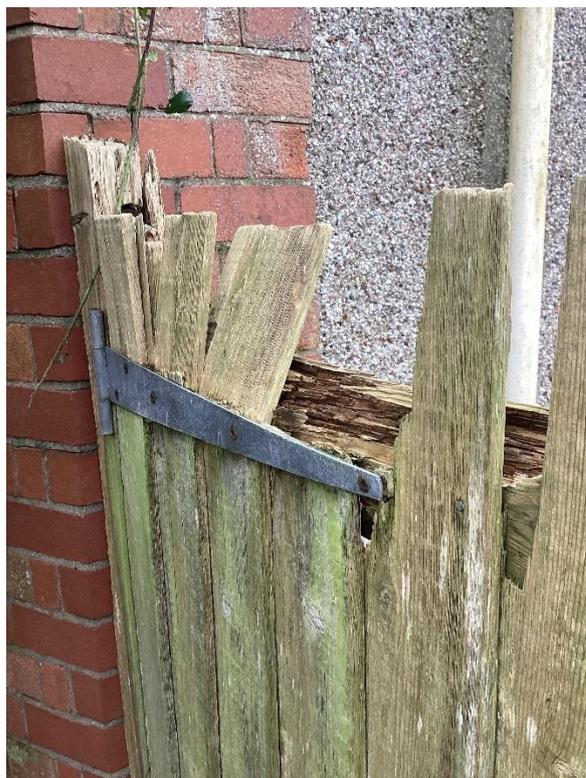
Photo 5.2.16

Deterioration to external gate to rear. The gate no longer opens without lifting.

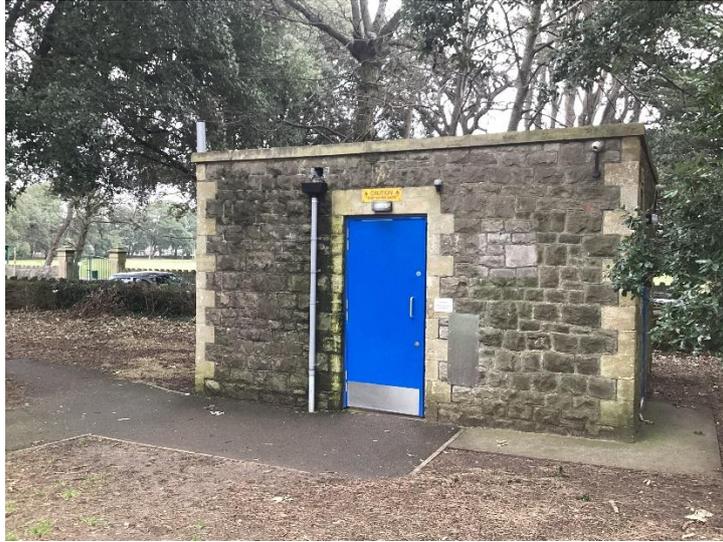
Photo 5.2.17

Front elevation of Clarence Park publicly accessible toilet. Note the algal growth to the wall to the left of the door.

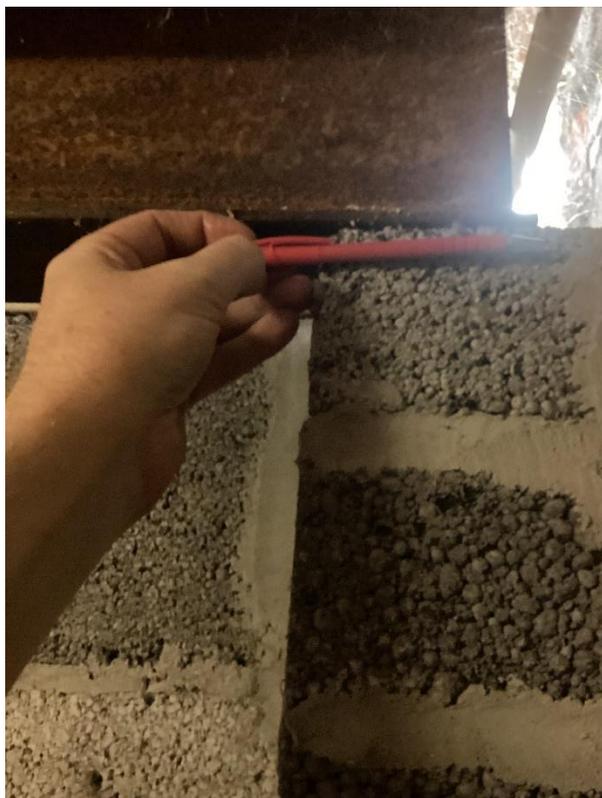
Photo 5.2.22

The bearing of the structural beam is less than the recommended 150mm.

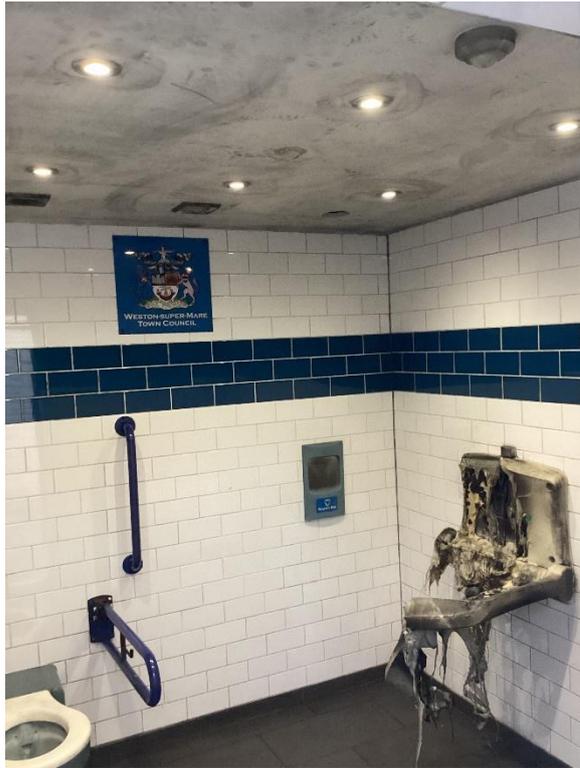
Photo 5.2.25

The public toilet had recently been subjected to arson and was closed to the public.

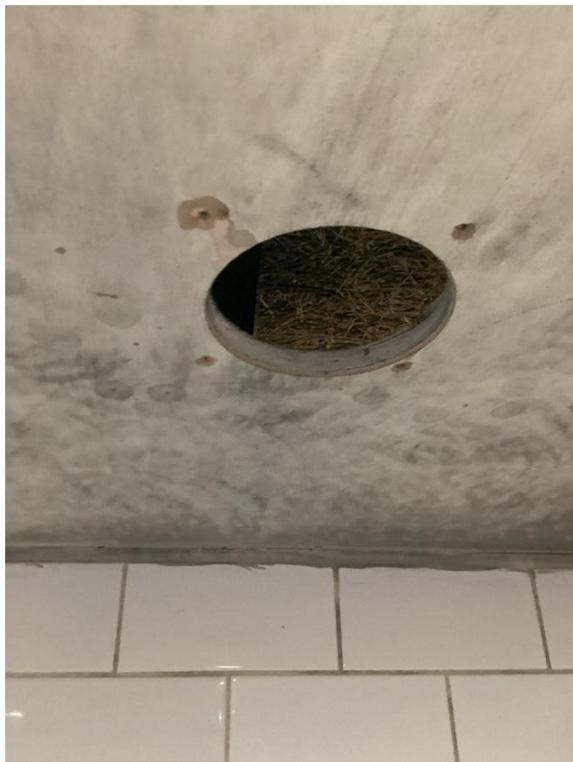
Photo 5.2.26

There is a lack of compartmentation at service voids between the accessible toilet and the service area.

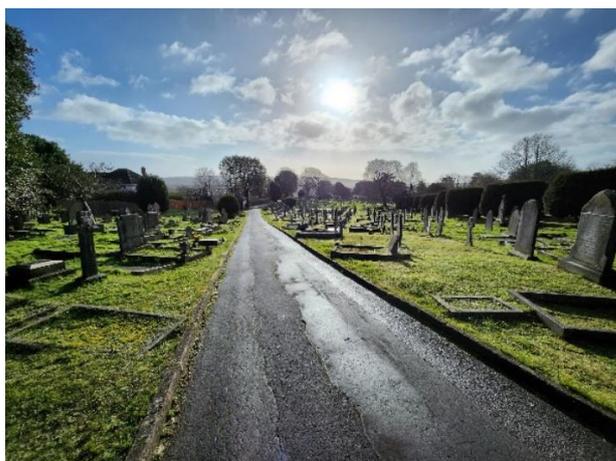
Photo 6.2.2  
Worn and uneven Tarmacadam path.

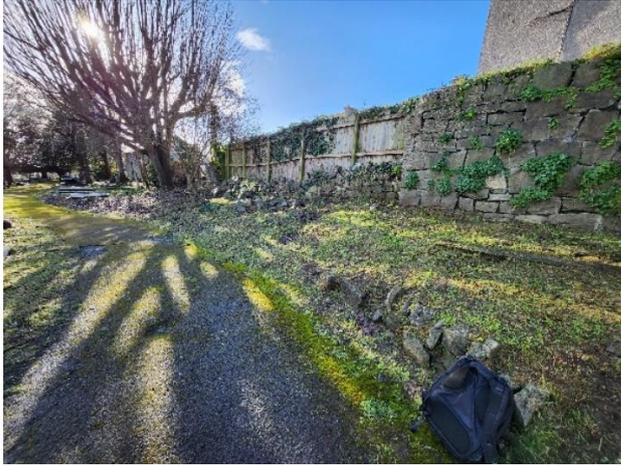
Photo 6.2.3

Perimeter wall requiring rebuilding.

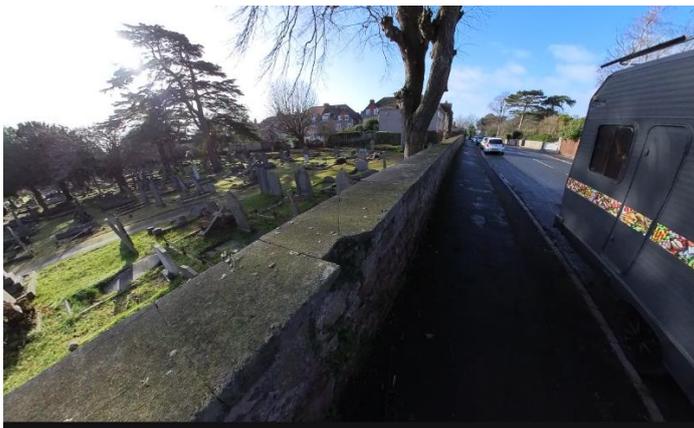
Photo 6.2.5

Cracked coping stone adjacent to  
Lower Bristol Road.

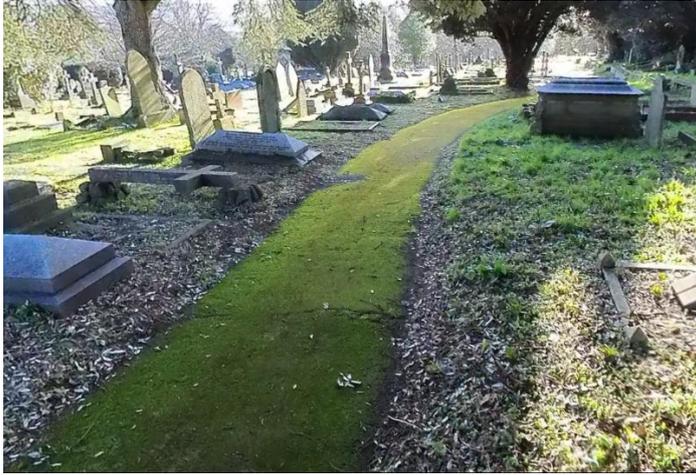
Photo 6.2.6

Moss covered pathway. Requires cleaning.

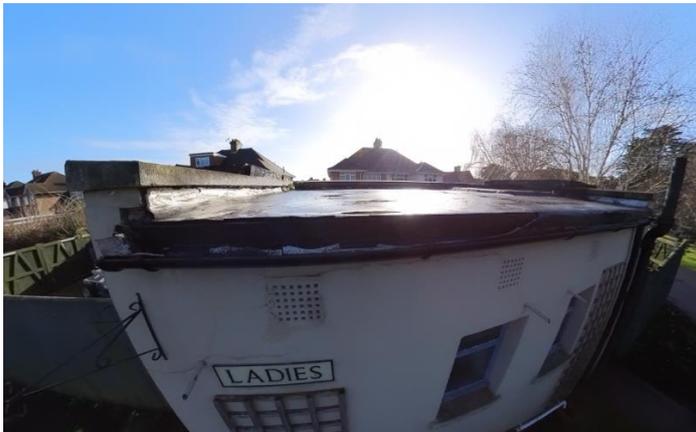
Photo 6.2.7

Split to roof covering near drip detail to gutter. Poor condition generally. Replacement recommended.

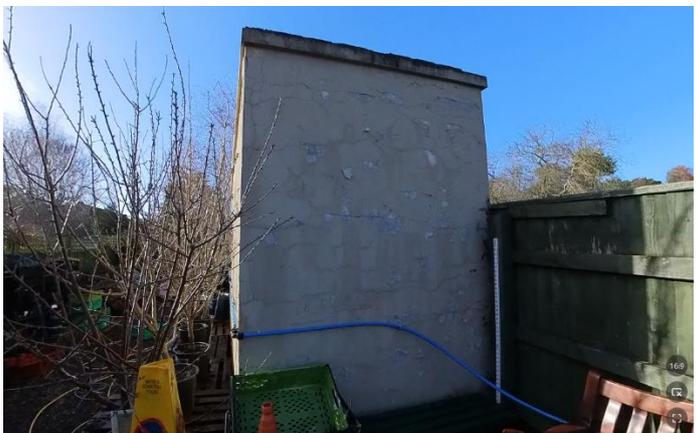
Photo 6.2.8

Widespread crazed cracking to render suggesting that it is approaching the end of its service life.
