**Policy and Finance Committee Meeting 15<sup>th</sup> April 2024**  
**Building Condition and Life Cycle / Planned and Preventative Maintenance**  
**Report**  
**Report of the Deputy Town Clerk**

# Weston-super-Mare Town Council

### Building condition and Life Cycle / PPM report 504524

28 March 2024

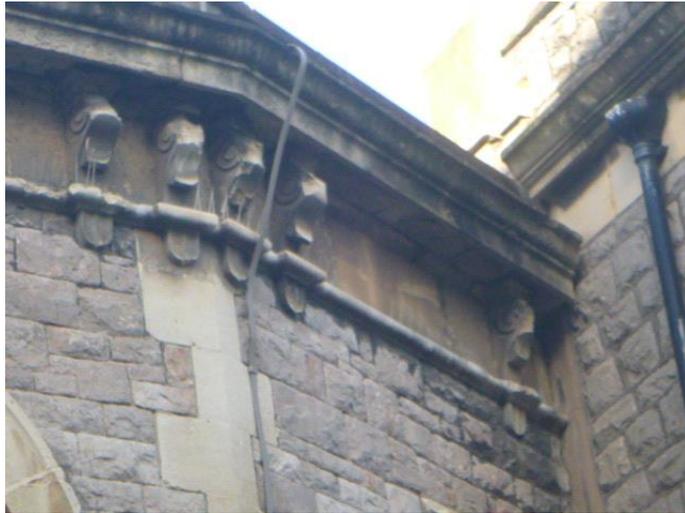
The external elevations display a varying degree of stone erosion with some isolated open mortar joints that will require on-going cyclical assessment to ensure high level stonework does not spall and cause injury. Tap testing is recommended.

Photo 2.2.: Further cornice erosion.

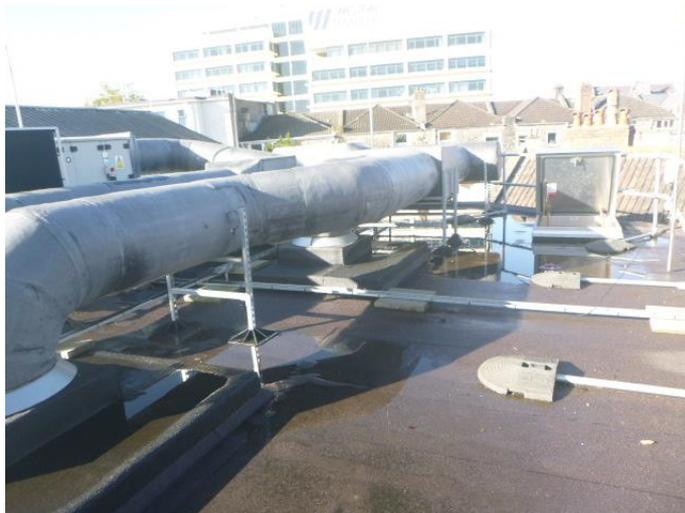
Photo 2.5: Ducted ventilation plant sited on the roof and serving the auditorium and second rehearsal stage room.

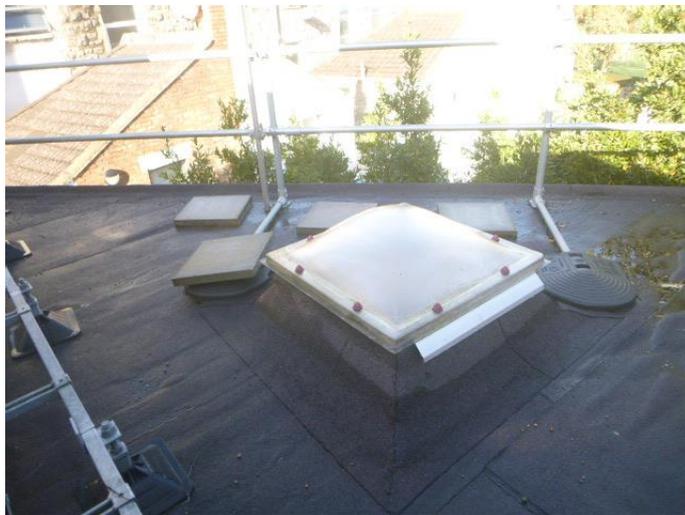
Photo 2.6: Flat roof areas with polycarbonate roof lights prone to ponding rainwater and silting due to poor gradients across the roof.

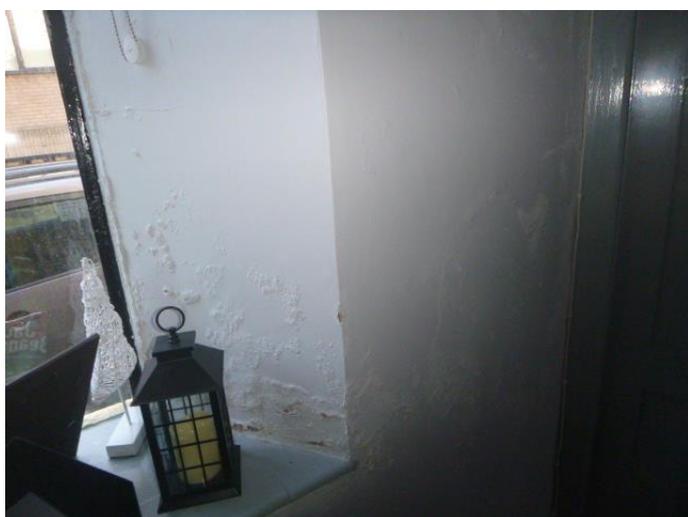
There have been severe rain penetration issues around the Blakehay, which has caused extensive damage to internal wall finishes including the auditorium, café and second stage rooms. These issues remain partly unsolved and further investigation and repairs will need to be carried out and budgeted for.

Photo 2.9: Penetrating dampness around café/bar windows

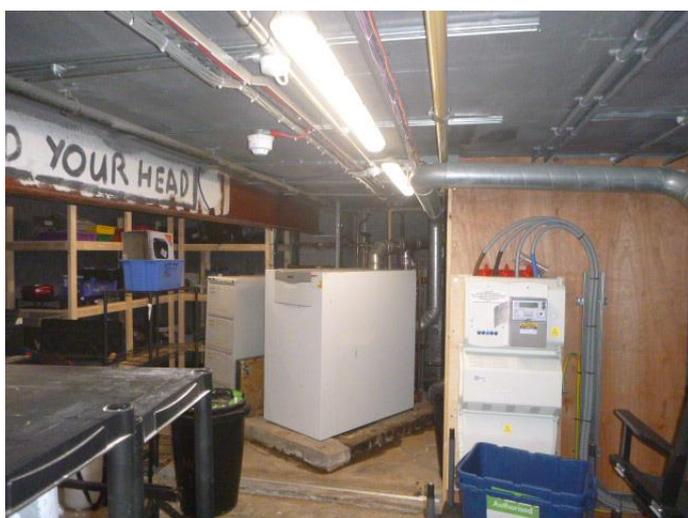
Generally, the mechanical and electrical services are visually in acceptable repair, but the location of the internal water header tank (above the main stairs) may cause serious water damage if leakage occurs.

Photo 2.10: General view of the boiler room and basement location

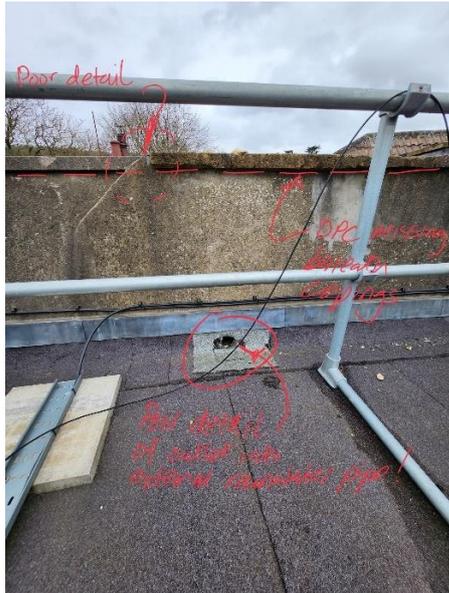
A subsequent inspection was made in March 2024 which identified a 4-metre section of the parapet wall that lacked a DPC beneath the coping stones. One of the coping stones was cracked and the joints were weathered. There was poor detailing at the parapet outlet that requires improvement. The outlet would typically be dressed to discharge into a hopper, but this arrangement is missing.

Photo 2.13: Poor detailing at rainwater outlet

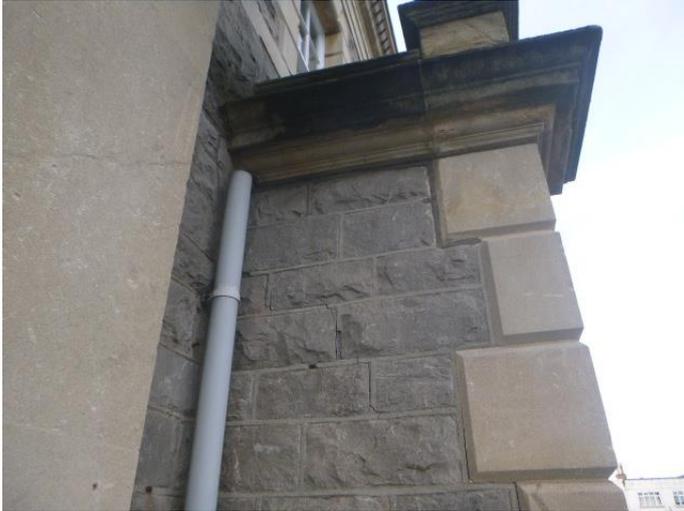
The main issue noted at the museum is the outward rotational movement to the front ground floor bay structures with cracking evident at the bay – elevation abutments. This requires further investigation with potential for structural strapping between the affected masonry to prevent further rotation outward.

Photo 3.2.2  
Rotational movement noted to the bays structure away from the front elevation.

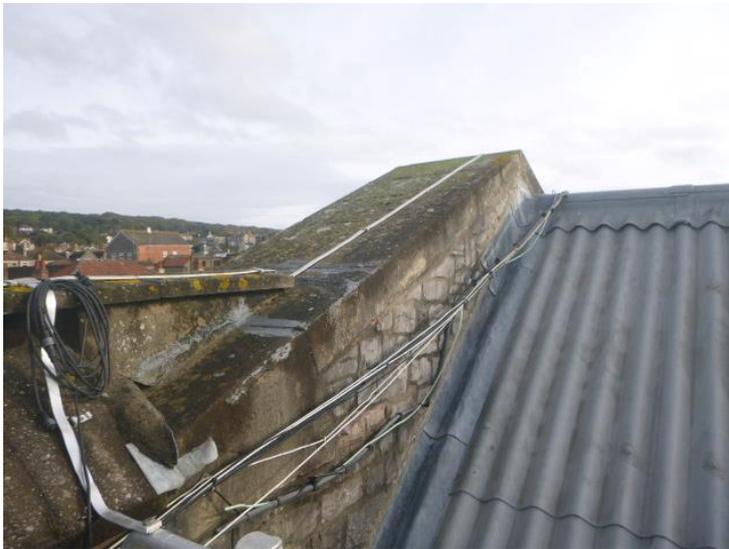
There appears to be encapsulated asbestos roof sheets serving the pitched structure over the first-floor function room. Presently, this shows no indication of wear and failure of the heavy paint encapsulation. Work to replace it would be expensive and onerous if the need arose.

Photo 3.2.6  
View of the encapsulated  
asbestos roof over the Function  
Room. Temporary Acrypol  
repairs to cornice junctions.

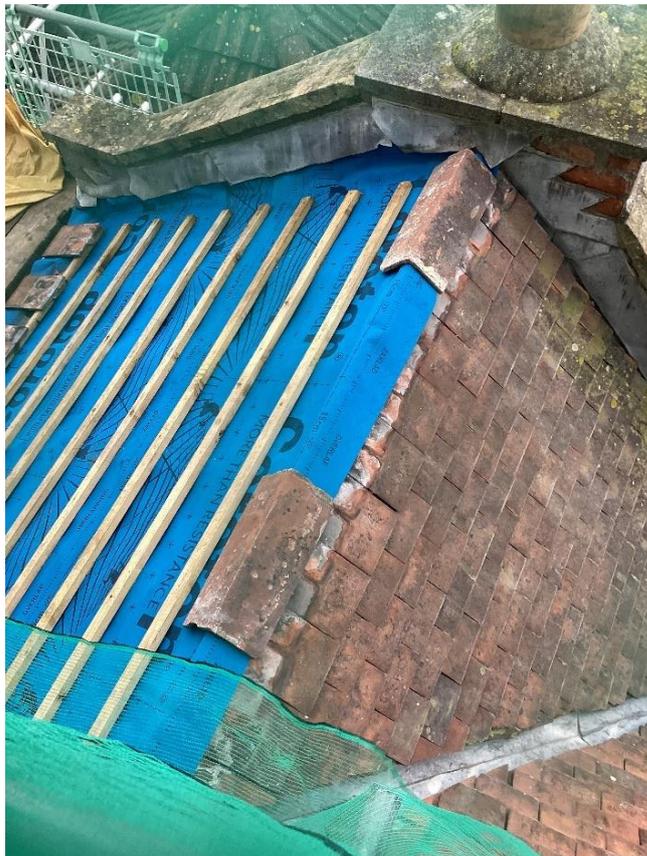
Photo 4.2.9

Breathable underlay to the rear pitched roof at the second floor. Unsure if the whole roof has been or will be included in the refurbishment.

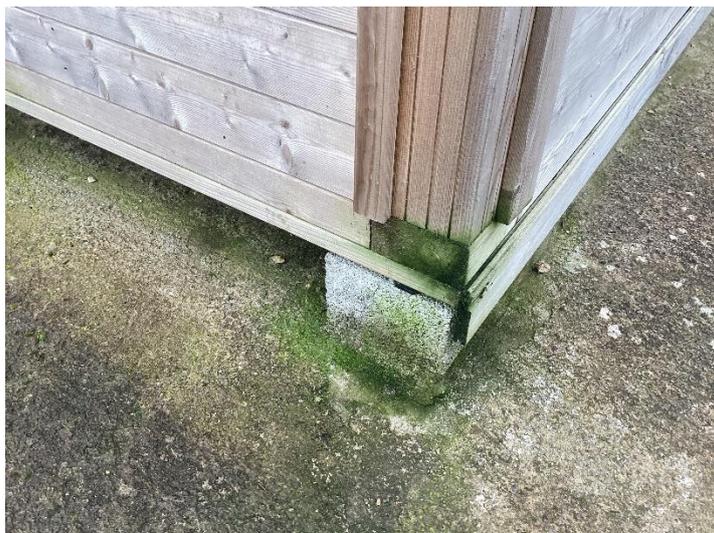
Photo 5.2.3

Algal growth to base of visitors centre.

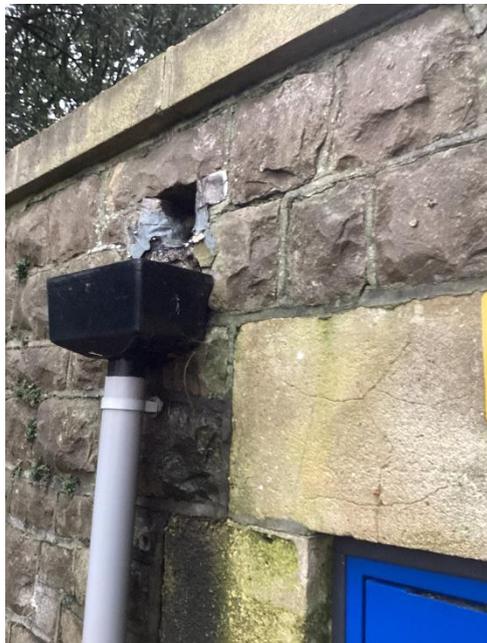
Photo 5.2.18

Lack of dressing to the outflow from the parapet. Water currently cascades down the wall rather than being collected by the hopper, causing the algal growth on the wall.

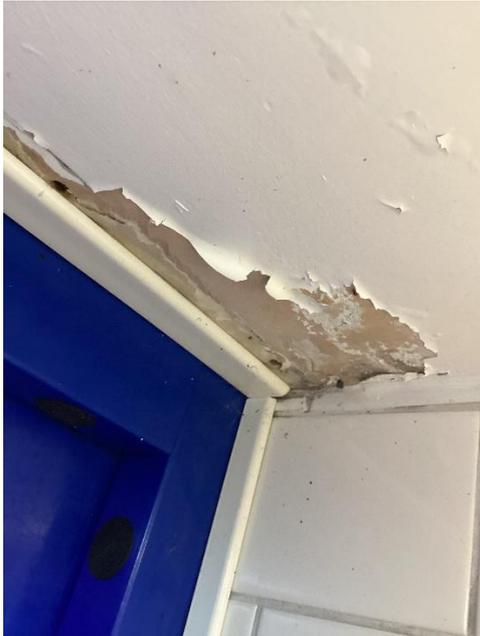
Photo 5.2.19

Flaking paint at high level near the door. This could be related to the hopper issue externally.

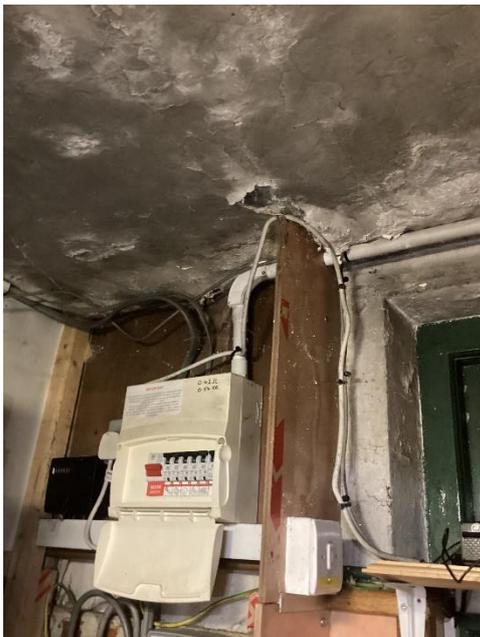
Photo 5.2.20

Damp penetration at high level in the service area, near the consumer unit. This appears to be a different issue to the hopper issue and further investigation is advised.

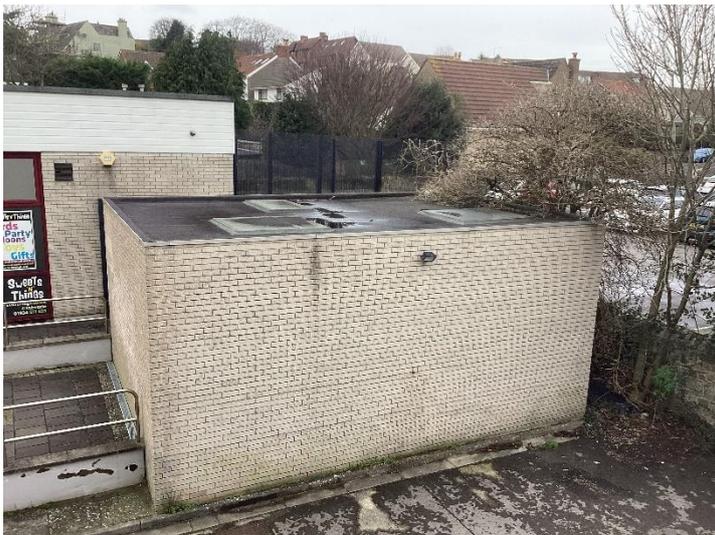
Photo 5.2.24

The roof shows signs of some ponding and areas where the rooflights have been covered over.

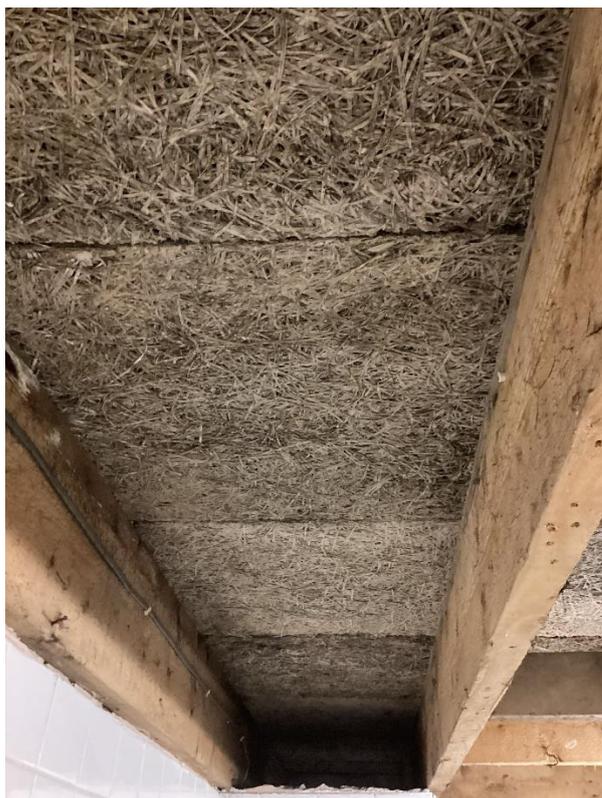
Photo 5.2.27

Wood wool slabs form the structure. These do typically provide a degree of fire protection.

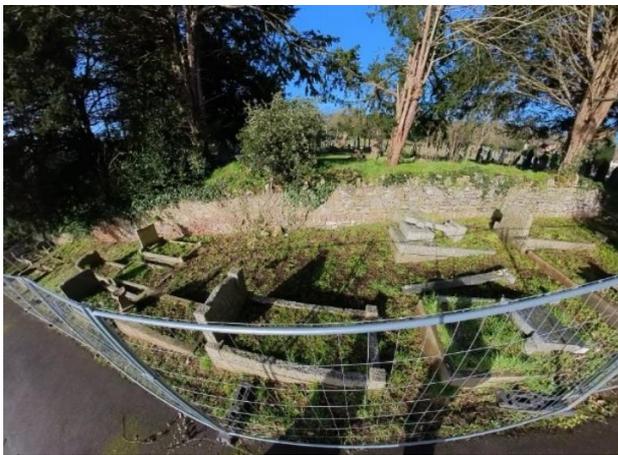
Photo 6.2.4

Chart 6.1.6 shows the estimated spend for all elements, each year for 5 years. This includes items rated as C and D from the table above. The main costs in the first year relate to rebuilding the retaining wall near the engine shed, and renewing the roof for the public toilets. In year three the costs are attributable mainly to repair sections of the tarmacadam path that most need it.

Retaining wall at risk of collapse.
